## The Rest of the Story

### Part 3

BY BRUCE BARKER

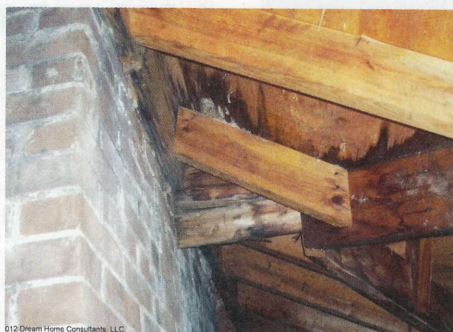
Photo 1

There were obvious signs of water entry in the attic on the framing around the chimney. See photo 1. Our inspector, Bruce Ramsey, and I assumed the water was from poor chimney flashing. The existing flashing wasn't too bad, but it also looked recently repaired. See photo 2. No doubt most of the water entry was due to flashing issues, but not all of it. When we started removing the chimney, we found that the masonry was also wet above the roof line. See photo 3. Some of the water was apparently entering through the chimney cap (crown).

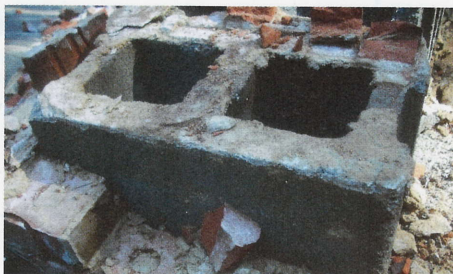
The chimney crown was typical of those we often see. It was a relatively thin layer of mortar tapering to almost nothing at the edges. Some call this thin mortar layer a mortar wash, which is a more accurate term. It was cracked, but not badly. Water was apparently entering as shown by the dark areas on the blocks in photo 3.

Many chimney crowns are constructed like the one on our home. It was deficient and leaking even though we could not determine this by a visual inspection. Most crowns like ours should be reported as deficient based on failure to comply with industry-recommended installation guidelines.

The first problem is using mortar for the crown. Mortar is not intended for this purpose. A proper crown is made from concrete, either cast-in-place or precast. The second problem is thickness, especially at the edge. Thin concrete and mortar will deteriorate and crack. The minimum crown thickness should be 2 inches, even at the edge. The third problem is ending the crown at the chimney edge. Water will run down the chimney causing the brick and mortar to deteriorate. The crown should extend beyond the chimney at least 2 ½ inches on all sides and have a drip edge on the underside of the crown. See Figure 2.

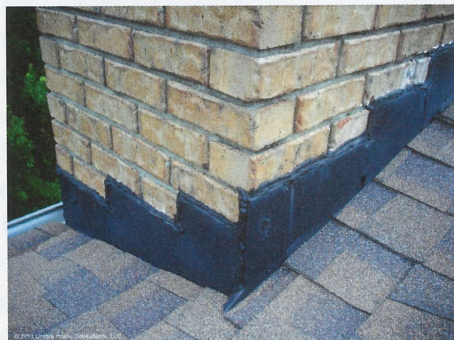
the roof covering underlayment (for shingle roof coverings). Counter flashing should be inserted into a notch cut in the mortar and sealed in place with a high-quality caulk or with mortar. The counter flashing should be flush with the base flashing and overlap it at least 3 inches. Photo 4 shows an acceptable chimney flashing job. The fasteners aren't good, but it looks like the counter flashing is inserted into a notch as it should be.

The cricket should be flashed at the chimney using base and counter flashing, and the roof covering material should be installed on the cricket in a manner appropriate for the roof covering. A metal cricket cover is also acceptable. Picture 4 also shows part of a cricket.

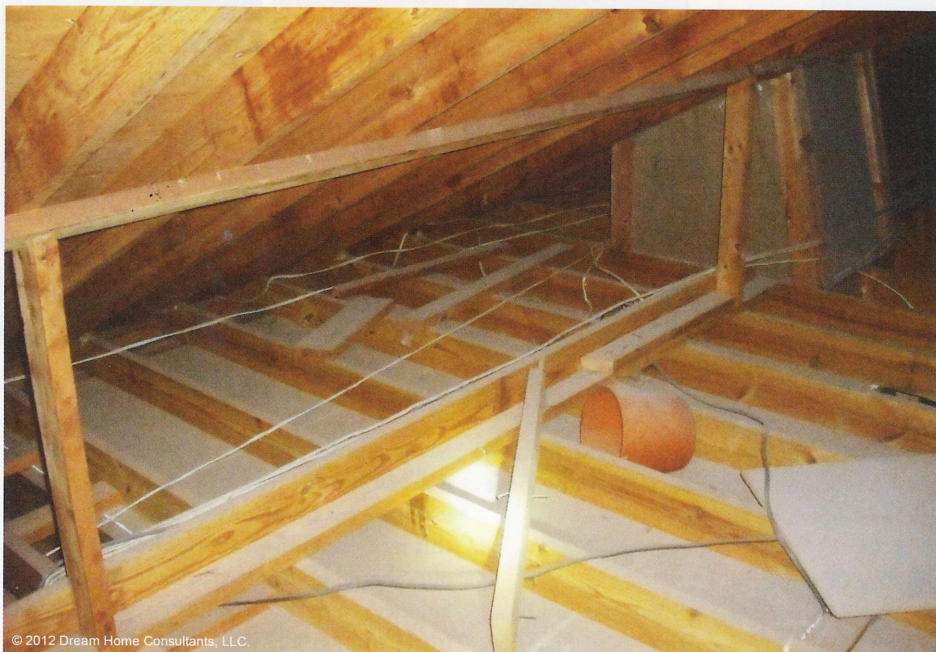
Let's look at the purlins first. The removed braces are obvious as shown in Photo 5 on page 20. What may be less obvious is the fact that the purlins are not properly installed in the first place. Figure 3 shows proper purlin installation.

Purlins let the builder use longer or smaller rafters than would otherwise be allowed. They do this by transmitting some of the rafter load to a load-bearing point, usually a load-bearing wall. The problem in this case is that the purlin support was near the middle of the ceiling joist span, not exactly a load-bearing point. To be fair, after more than 30 years there was no indication that the improperly installed purlins had caused any problems. That said, problems could occur under the right conditions, so you should report improper framing such as these purlins even if there are no visible problems yet.

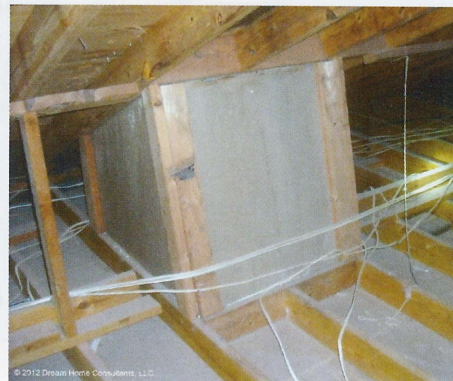
Photo 6 shows how the skylight was framed. Note that the single header is run between two original single rafters that were almost certainly not designed to carry the additional load. The same condition exists on the low side of the skylight. As for the ceiling joist header, the right side is just hanging there, as it was on the low side of the skylight. Again, there were no visible problems, but this one could cause problems and needed to be fixed.

Frankly, we both missed the skylight framing. Even experienced inspectors don't catch everything. The repair wasn't easy or

inexpensive. Dealing with long lumber when drywall and other framing are in the way isn't much fun. And a well-known joist hanger manufacturer charges a lot for triple hangers. At least we already had big sections cut out of the ceiling for some access.

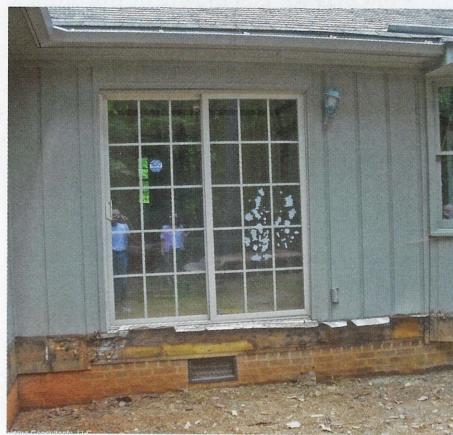
Remodeling is difficult, even for conscientious contractors who know what they're doing. There are many opportunities for mistakes, especially when the work is done by handymen, the low-bid contractor or by a well-meaning neighbor. Photo 7 shows the damage caused, in part, by the neighbor who replaced a hung door with a sliding door. The improper flashing allowed significant water damage that was only visible when we removed the deck.
