Here's a look at the framing and flashing details that contractors keep getting wrong

by Bruce Barker

Deck Ledger Attachment

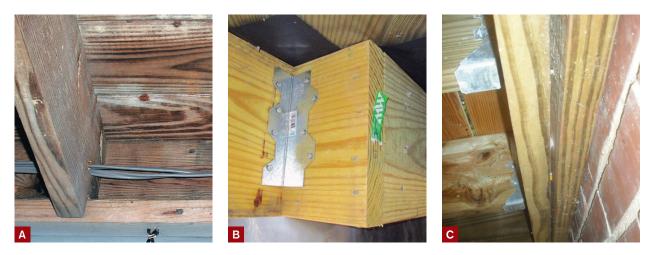
Figure 1. Older decks frequently have ledgers that have been nailed rather than screwed or bolted to the house (A), but the author sometimes finds this problem on recently built decks too (B). Note the nailed double-ledger connection, which is in the process of separating, in photo (C).

find ledgers that have been nailed to the framing, which is prohibited by both DCA 6-15 and the IRC (**Figure 1**). When I do, I complete my inspection, then explain the risks to my clients and advise them (and their real estate agent) not to walk on the deck until it is properly attached to the house. In my report, I highlight this defect in red ink to emphasize the importance of this finding and recommendation.

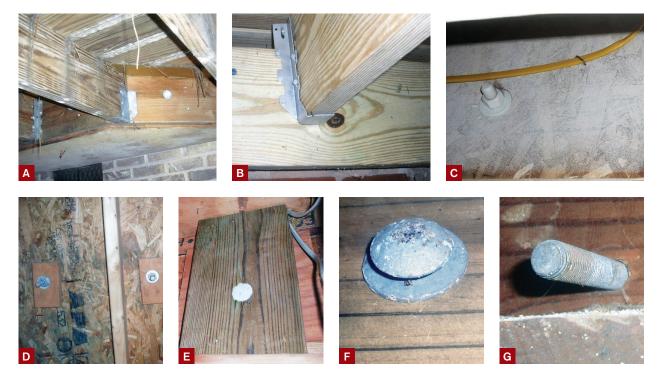
Figure 2. Ledgers shouldn't be fastened to a cantilevered projection (A), to brick veneer (especially with masonry screws) (B), to the web of an I-joist rim board (C), or to OSB sheathing (D). This ledger, on a year-old deck, was fastened to an I-joist rim board with carriage bolts; neither the fasteners nor the method are allowed by code, despite the blocking (E). Adding a washer to a carriage bolt doesn't make the connection code compliant (F), but it's better than forgetting the nut and washer (G). Also note that this bolt is too close to the edge of the rim joist and could cause it to split.

Even when bolts or screws are used to attach the deck ledger to the building, many of these deck ledgers are improperly installed. I've seen plenty of creative—but incorrect—ways to attach a deck ledger to a building. I've discovered ledgers that have been bolted to masonry walls, to OSB sheathing, and even to the web of an I-joist rim board (**Figure 2**).

Another problem is ledgers that are attached to cantilevers. Because cantilevers aren't typically designed to support the loads from a deck, both the IRC and DCA 6 require that the band joist supporting the deck ledger be fully bearing on the structure, effectively prohibiting attachment of a deck ledger to a cantilever.

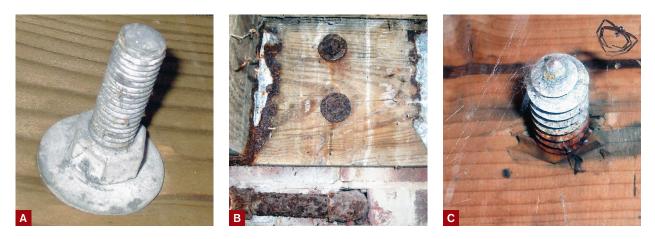
Figure 4. The white rust on this ledger bolt indicates that it is still safe but is nearing the end of its service life (A). The extensive red rust on these bolts indicates that the hardware should be replaced immediately (B). Water intrusion is causing wood rot and the red rust on this lag bolt; the connection is likely weakened (C).

One of the most important things I look for when inspecting a deck or balcony is white or red rust. White rust appears on metal hardware as white stains, indicating that the protective zinc coating (galvanization) is deteriorating. While white rust indicates that hardware is nearing the end of its service life and should be monitored regularly, significant red rust indicates that the component has reached the end of its service life and should be replaced (**Figure 4**).

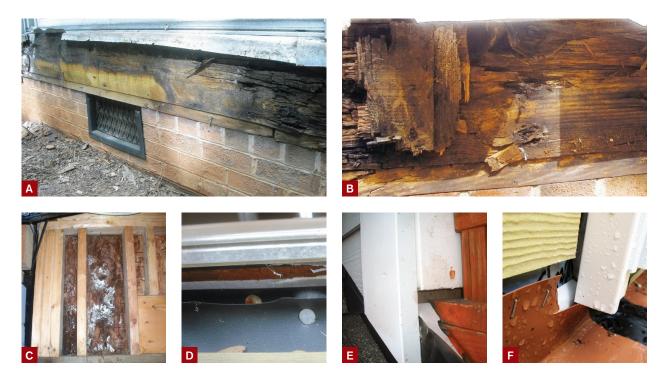
It won't matter how well a deck ledger is attached to a building if the band joist or rim board it's attached to is waterdamaged. The bolts or screws may withdraw from water-damaged wood, and if this occurs, the deck will collapse. Even though flashing details are not spelled out in the IRC, properly installed deck flashing is essential for the long-term structural integrity of a deck (**Figure 5**).

Figure 5. The sheathing and band joists on these homes (A, B) are in rough shape, thanks to moisture intrusion from their decks, and require replacement. Improperly installed ledger flashing on a one-year-old deck was the cause of this water damage (C). Flashing is often improperly installed underneath door thresholds (D) and where ledgers intersect with other building components, such as a roof (E). During a new-home inspection, the author discovered flashing that hadn't been integrated with the water-resistive barrier underneath the home's siding (F).
