Dream Home Consultants, LLC.

CONFIDENTIAL INSPECTION REPORT

1234 Main Street, Raleigh, North Carolina 27510

7/5/2020 8:00 am to 1:00 pm

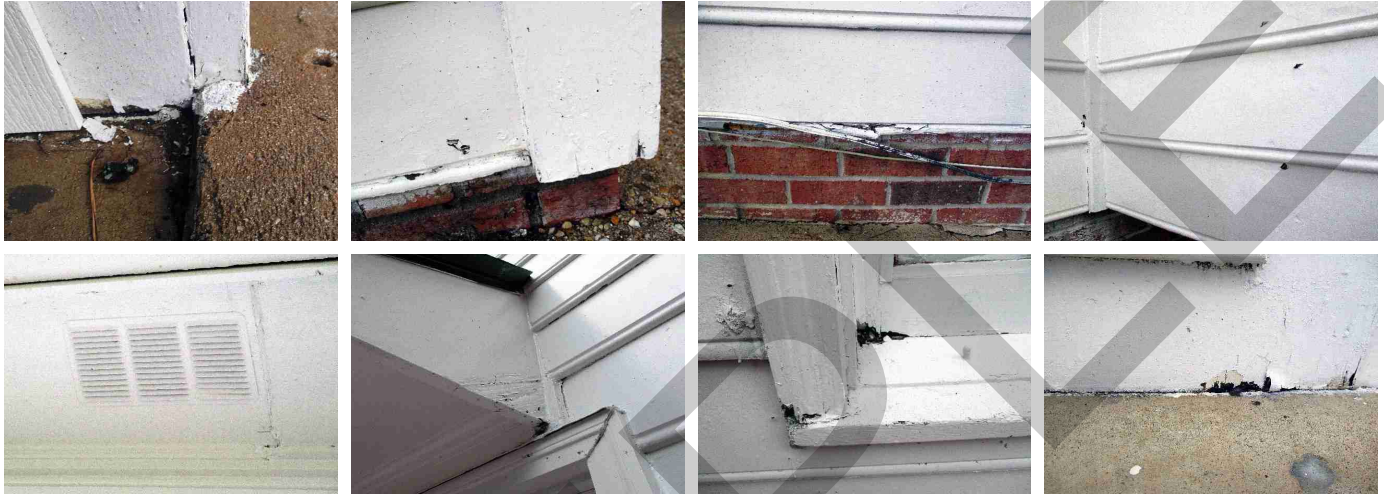
We observed that the wall covering, cornice, windows, or trim are water damaged. We recommend evaluation of the causes of the damage to all exterior wood by a qualified contractor and action as recommended by the contractor. The material requiring attention includes, but is not limited to: multiple locations. Picture(s), if any, are examples.

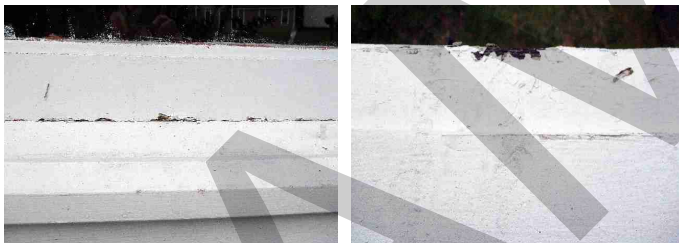
We observed deteriorated, faded, or peeling paint or stain on soffits, fascia, or trim. We observed no damage to the materials caused by this condition and we believe that this is currently a cosmetic issue. Paint and stain are the water resistant membranes that protect materials from moisture damage. We recommend full surface preparation and painting or staining by a qualified painter using materials intended for exterior use. The materials requiring attention include: paint on wood windows and trim. Picture(s), if any, are examples.

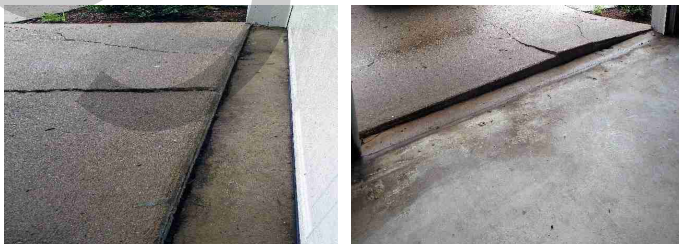
We observed a difference in height where the driveway meets the garage floor. This is a trip and fall hazard.

This may indicate uneven settlement or uplift between the two components. One guideline recommends that height differences not exceed 1/2 inch. We recommend evaluation of the reasons for the deficiency and action as recommended by a qualified contractor. Picture(s), if any, are examples.

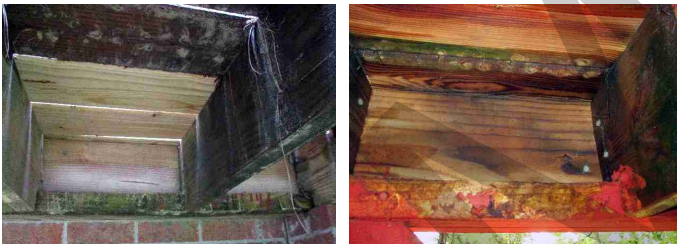
Wood structures that are near the end of their service lives usually present safety deficiencies that can cause injury. These wood structures usually do not comply with current accepted construction standards for components such as: flashing that reduces water intrusion into the structure; attachment to the structure that reduces that chance for deck collapse; stairway handrails, treads, and landings that reduce the chance of injuries due to falls; framing and fasteners that reduce the chance for deck collapse; and footings and support posts that reduce the chance for deck collapse.

We recommend evaluation by a qualified contractor and action as recommended by the contractor according to current accepted standards. Action may include replacement of the structure. The structure(s) requiring specific attention include: the rear deck. Picture(s), if any, are examples.

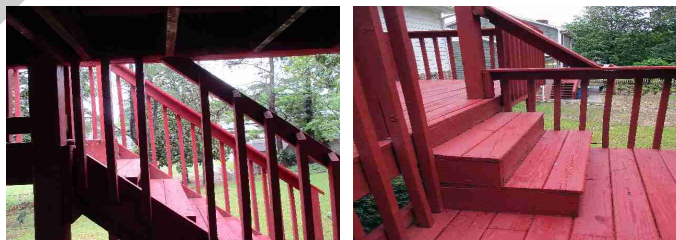
We observed that openings in guards at raised surfaces are larger than currently recommended. This is a strangulation and a fall safety hazard for children. Current accepted standards recommend that required guards on open sides of stairways, raised floor areas, balconies and porches shall have intermediate rails or ornamental closures which do not allow passage of a sphere 4 inches or more in diameter. Exceptions: 1. The triangular openings formed by the riser, tread and bottom rail of a guard at the open side of a stairway are permitted to be of such a size that a sphere 6 inches cannot pass through. 2. Openings for required guards on the sides of stair treads shall not allow a sphere 4 3/8 inches to pass through. We recommend repair of all non-compliant guards by a qualified contractor.

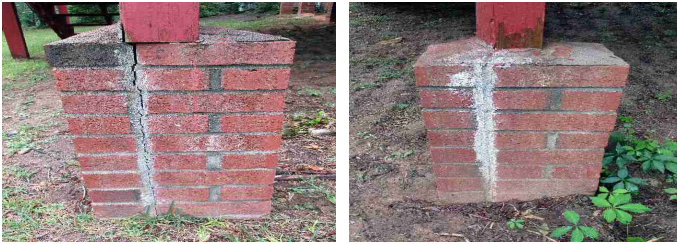
Footings damaged evaluation recommended - *Continued*

We observed that footings supporting a deck, balcony, stair, or landing present damage. This can cause a structure collapse causing injury. We recommend evaluation by a qualified contractor according to DCA 6 guidelines and action, if any, as recommended by those guidelines. The footings requiring attention include: the rear deck. Picture(s), if any, are examples.

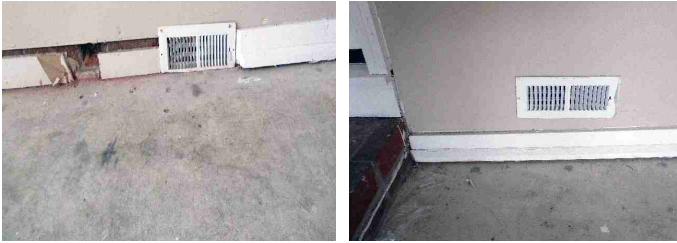
We observed an HVAC supply or return opening in the garage. This is a fire safety hazard and a carbon monoxide hazard. HVAC openings in a garage can allow fire to spread into the home and can circulate car exhaust into the home. Current accepted standards recommend that ducts shall have no openings into the garage unless the HVAC system serves only the garage. We recommend action by a qualified HVAC contractor. Picture(s), if any, are examples.

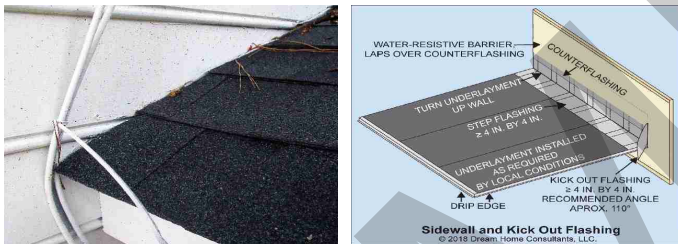
We observed that sidewall kick out flashing is absent where recommended. Sidewall kick out flashing should be installed where a vertical sidewall extends past the end of a roof. Sidewall kick out flashing should turn at least 4 inches away from the wall. Lack of this flashing is a common cause of water leaks and damaged exterior wall covering material. Water leaks can damage materials and provide moisture for fungal growth. We recommend action by a qualified roofer. The areas requiring attention include: all roof/sidewall intersections. Picture(s), if any, are examples.

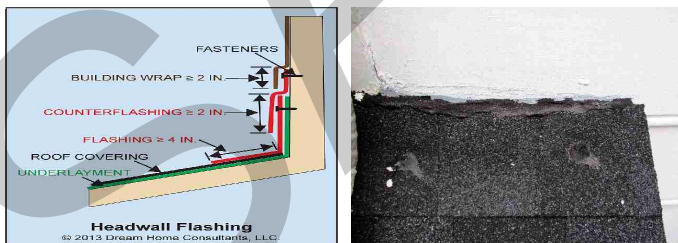
We observed poor headwall flashing installation. Poor flashing installation is a common cause of water leaks. Water leaks can damage materials and provide moisture for fungal growth. Headwall flashing: (1) should be installed with upper sections installed shingle-fashion over lower sections, (2) should be properly integrated with other sidewall covering materials to form a water-resistant drainage plane, (3) should have any exposed top edge covered by counter flashing. We recommend installation of headwall flashing by a qualified contractor according to accepted practices such as those described EEBA Water Management Guide or other authoritative reference. The flashing requiring attention includes: all visible headwalls. Picture(s), if any, are examples.

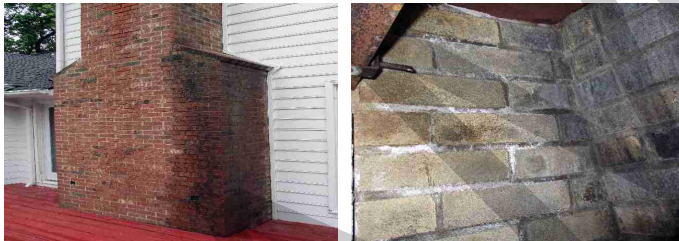
We observed unusual water staining on the chimney walls, and we observed efflorescence inside the firebox. We did not determine the cause of this condition. Water can deteriorate components and provide moisture for fungal growth. We recommend evaluation by a qualified contractor, and action, if any, as recommended by the contractor. Picture(s), if any, are examples.

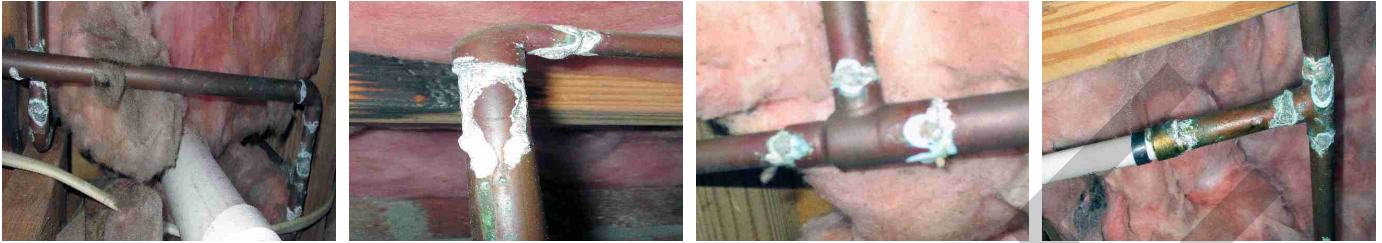
We observed mineral deposits and corrosion at copper water distribution tube fittings or tubes. This could indicate that the fittings or tubes are failing and could begin to leak. We recommend evaluation by a qualified plumber and action, if any, as recommended by the plumber. The fittings or tubes requiring attention include: most fittings in the crawlspace. Picture(s), if any, are examples.

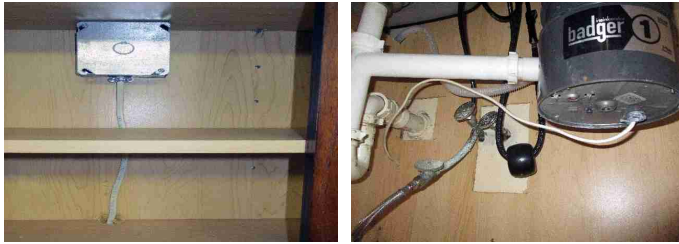
We observed NM, UF, or other similar electrical cable that is not properly protected against physical damage. This is an electrical shock and a fire safety hazard. Current accepted standards recommend that where subject to physical damage, cables shall be protected by conduit, electrical metallic tubing, Schedule 80 PVC rigid nonmetallic conduit, pipe, guard strips or other approved means. We recommend evaluation by a qualified electrician and action, if any, as recommended by the electrician. The cable requiring attention

includes: above the kitchen sink, under the kitchen sink. Picture(s), if any, are examples.

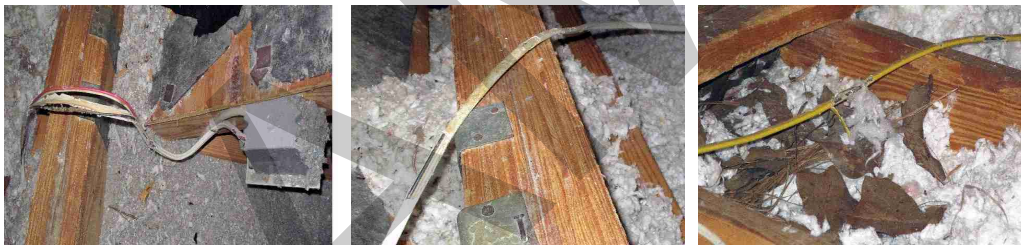
We observed damaged or deteriorated electrical cable or conductors, or cable or conductors. This is an electrical shock and a fire safety hazard. We recommend evaluation by a qualified electrician and action, if any, as recommended by the electrician. The cables or conductors requiring attention include: cables above the laundry area appear to have been chewed by rodents. Picture(s), if any, are examples.

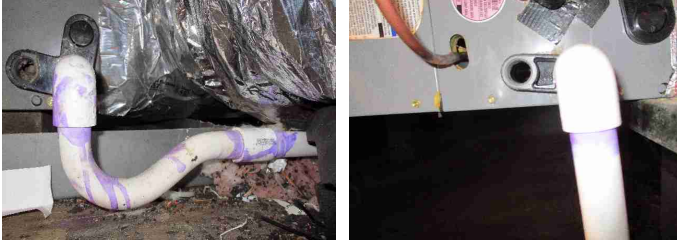
We observed an absent plug at an unused condensate drain opening. This allows conditioned air to escape into the unconditioned areas and may cause poor system performance and increase operating costs. We recommend action by a qualified HVAC contractor. The air handlers requiring attention include: both air handlers. Picture(s), if any, are examples.

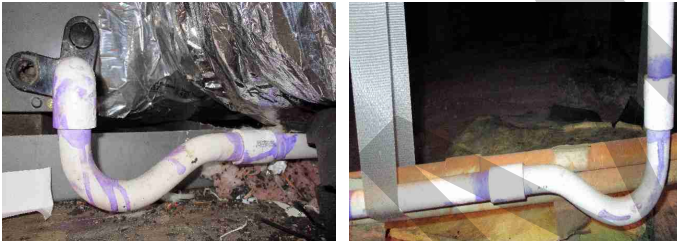
We observed a shallow trap on the primary condensate discharge pipes. This is sometimes called a running trap. These traps usually do not comply with manufacturer's instructions. They can drain causing air to escape from the pipe and causing water to spray inside the evaporator coil. We recommend action by a qualified HVAC contractor according to manufacturer's instructions. The condensate pipes requiring attention include: both air handler. Picture(s), if any, are examples.

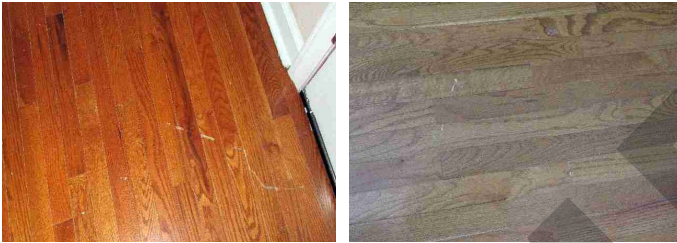
We observed that the floor covering is stained, worn, or damaged. This appears to be a cosmetic issue at this time. We recommend evaluation by a qualified floor covering contractor and action, if any, as recommended by the contractor. The floor coverings requiring attention include: in the foyer and in the dining room. Picture(s), if any, are examples.

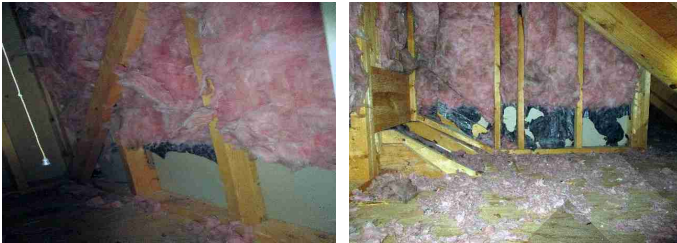
We observed that batt insulation is damaged. This will cause increased energy consumption, decreased comfort, and increased wear on HVAC components. We recommend that a qualified insulation contractor install insulation according to current energy efficiency standards. The areas requiring attention include: sidewall insulation in accessible attic areas. Picture(s), if any, are examples.
