## The Rest of the Story

### Part 3

BY BRUCE BARKER

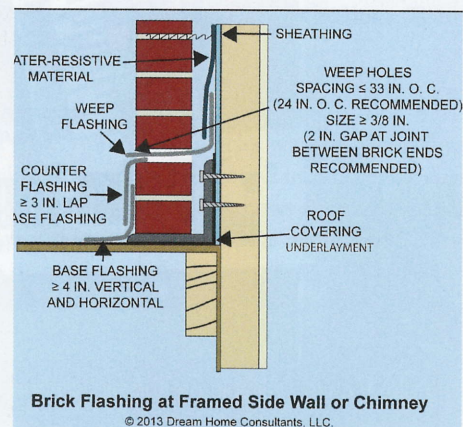
Figure 1

Brick Flashing at Framed Side Wall or Chimney

should drain through weep holes. This flashing method also applies to vertical sidewalls above roofs as shown by Figure 1.
