# The Word

A look at terms used in home inspection reports

# The Rest of the Story

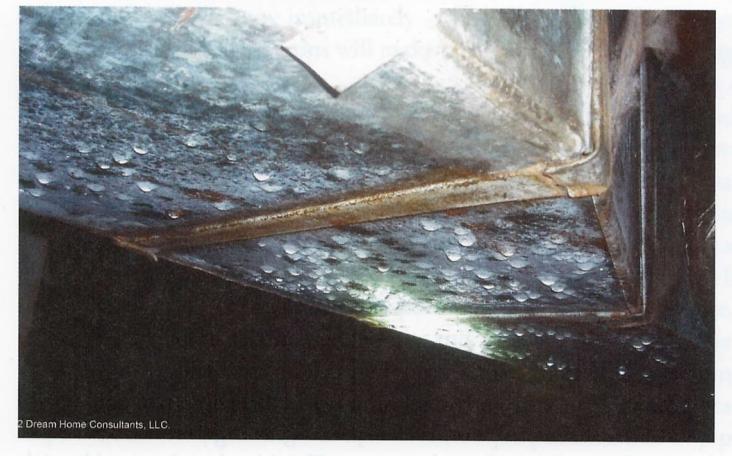
Figure 2

Have you ever seen rain in a crawlspace? That's what happens when you put leaky and poorly insulated ducts in a very humid environment then run the air conditioner. The duct temperature falls below the dew point and liquid water condenses out. It was literally raining under the supply ducts. See Figure 2. This added substantial liquid moisture to an already wet crawlspace. Be sure to report rain in a crawlspace if you see it.

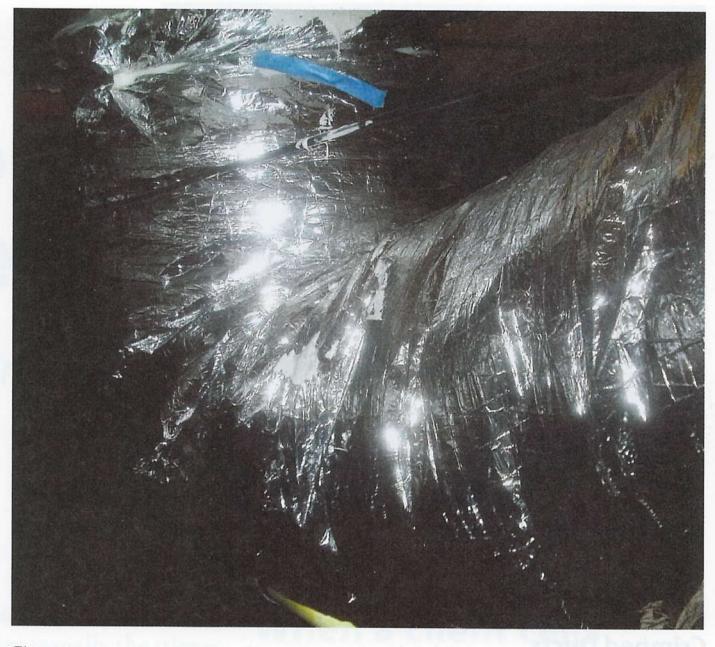
# Figure 3

If there's a lot of moisture on the outside of the ducts, or if the ducts aren't well sealed, there's a reasonable chance that the inside of the ducts aren't in very good shape. At best, the duct interior is probably gross (a technical term). At worst, think the evil M-word (mold). While it's unwise to speculate about the condition of components you can't see, you may want to recommend inspection of the duct interior if there's a reason to believe that its condition might rise to the level of gross. Figure 3 confirms that the duct interior was indeed quite gross.

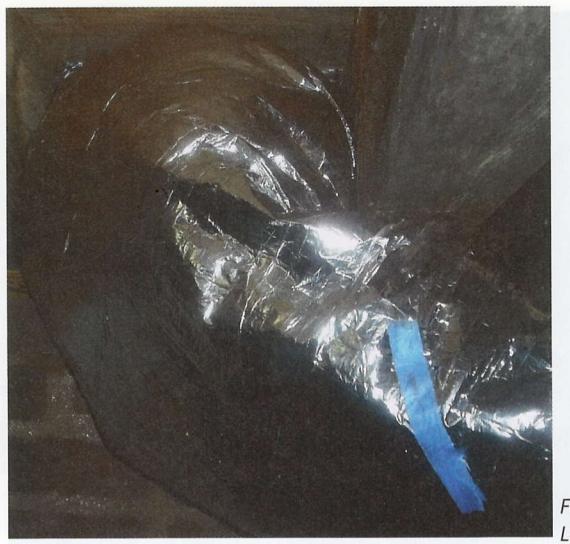
Aside from being gross (a big problem for The Word's wife who has severe dust allergies) the ducts were very leaky. Duct leakage 20% or more is common for duct systems installed before the last couple of years. Leaks are most common at duct attachment collars in plenums and distribution boxes, around supply and return boots, and at joints between duct sections. Many of these leak points are detectable during a typical inspection.

Figure 4: Leaky duct

Leaky ducts aren't just the way it was done back in the day. They are a reportable deficiency that costs clients money every day and exacerbates allergies and other health problems. The good news is that with a tub of mastic, some foil tape, some straps, and a few man-hours, leaky ducts that are otherwise in acceptable condition can be fixed at a very reasonable cost.

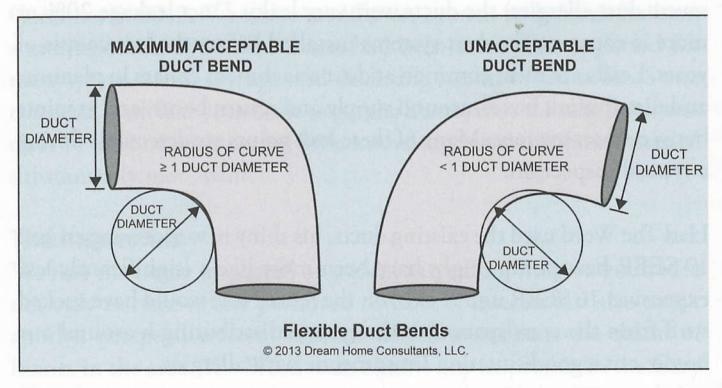
### Figure 5

While we're on the subject of poorly installed ducts, remember to look for crimped ducts, especially flex duct. A crimped duct reduces the duct area and disrupts air flow by causing air currents and eddies at the crimp. A crimped duct may not provide the air flow that the duct system designer specifies. Reduced air flow may cause comfort problems and may cause the HVAC system to run longer to move enough air to heat and cool the home.

Crimped ducts are very common. See Figures 3 and 4. These were the new ducts, much to The Word's displeasure. Illustration 1 shows the general rule for when flex duct is bent more than it should be. You should look for and report crimped ducts. They're usually easy to fix and doing so can make a big difference in HVAC system efficiency and effectiveness. For more on flex duct installation, go to the November 2005 issue of *The Reporter*.
